Fact Sheet for Dam Ownership: Vegetation and Erosion Control on Earthfill Dams

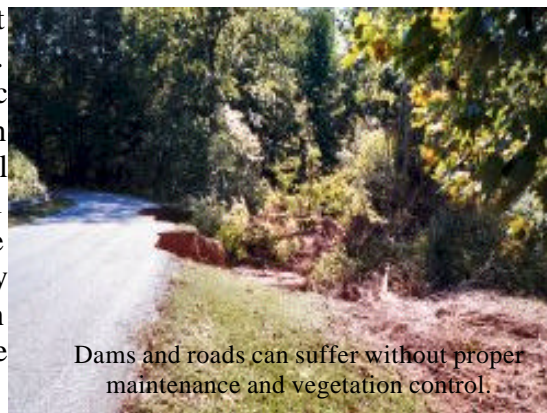
Dams and roads can suffer without proper maintenance and vegetation control.

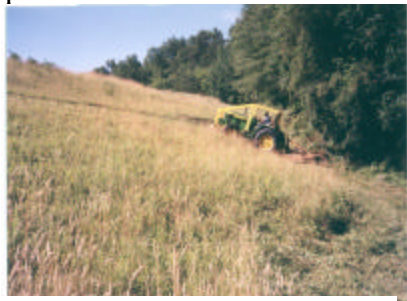
Grass growing on dams requires regular mowing.

The type of grass and its fertilization should be appropriate for local conditions. The proper vegetation should be established and maintained over the entire embankment, outlet, plunge pool and spillway area. Coverage should extend at least 25 feet beyond the abutment contacts and toe of the fill. Regular mowing throughout the year is essential so that the surface can be readily traversed by foot. Potential dam safety problems, such as misalignment, cracks, animal burrows, surface erosion, seepage, sloughing, etc. can be spotted early enough to take corrective action. Therefore, mowing should precede each dam inspection.
